**Michael D. Coats**  
Vice President, Chevron Mining Inc.

September 28, 2018

**Re:** Chevron Mining, Inc., Questa Mine; Multi-Sector General Permit (MSGP); SIC 1061; NPDES Compliance, Evaluation Inspection; NMR053300; July 24 through July 26, 2018

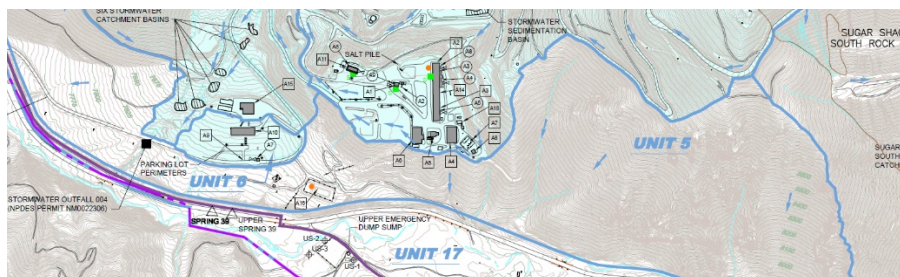
**Unnamed rock piles are shown at the southern mine property boundary in Unit 5 and Unit 4 on the SWPPP Mine Site Map, but do not appear to be specifically discussed in the SWPPP.**

The SWPPP identifies and defines Unit 4 on page 8 under Section 1.6 "Site Map". The Sugar Shack South Rock Piles (Unit 4) are again discussed in Section 2: "Potential Pollutant Sources" and Section 2.1 "Potential Pollutants Associated with Industrial Activity". These areas are referenced on page 15,

Section 2.3 “Unauthorized Non-stormwater Discharges Documentation” in the table that identifies “authorized non-stormwater discharges, source locations, and associated outfalls for the mine”. Lastly, page 21, under “Stormwater Control and BMP Maintenance” (b) the maintenance commitment to the stormwater controls are specified. Based on CMI inventory, there are a total of 9 rock piles all have been named and identified on the map.

Unit 5 has no rock pile disturbance, therefore there are none to identify.
